ELECTRIC FOUNTAIN

Year Built: 1931

Fountain Architect: Ralph Flewelling

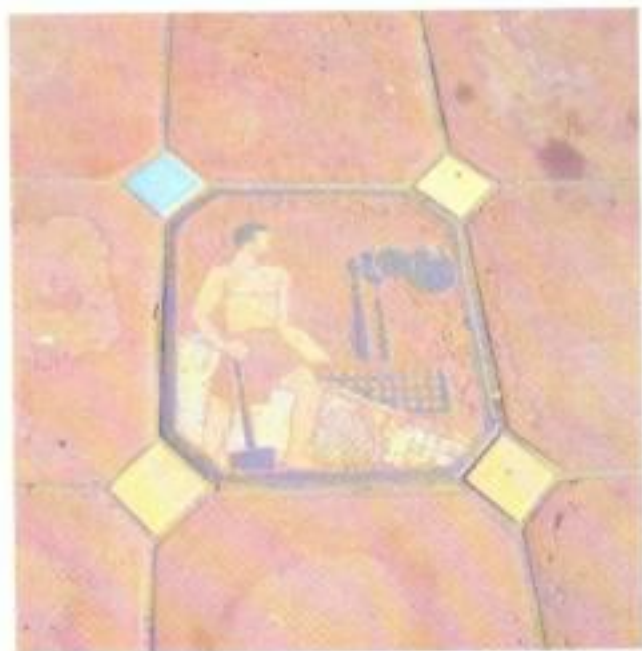
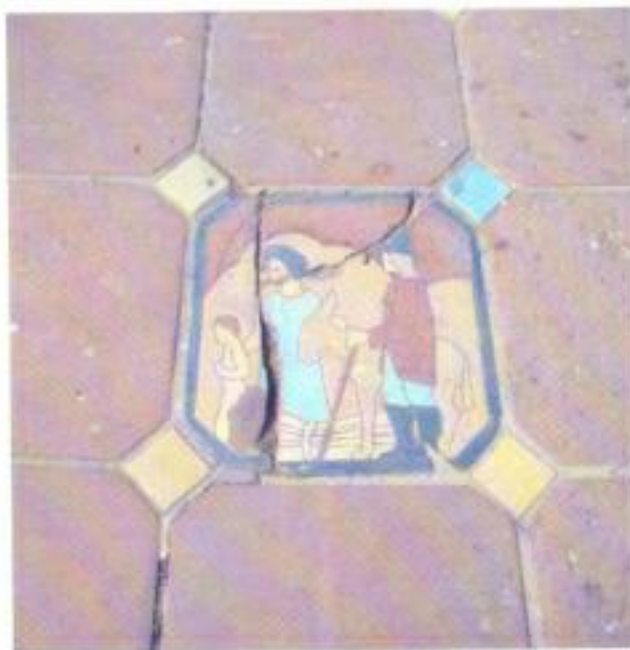
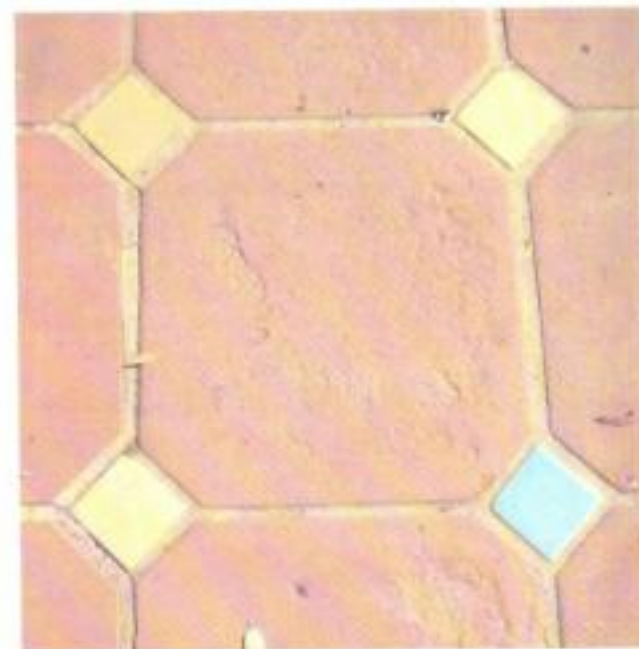
**32 CALIFORNIA HISTORY SCENE TERRA COTTA PAVER TILES
500-3" YELLOW GLAZED TILES and 190-3" BLUE GLAZED TILES**

- Clean Tiles with Aqueous and Solvent Based Cleaners
- Losses in Tiles to be Filled with Material
- Reproduction of Some Tiles
- Patches to be Toned to Mimic Existing
- Sealing to Protect from Excessive Water Penetration

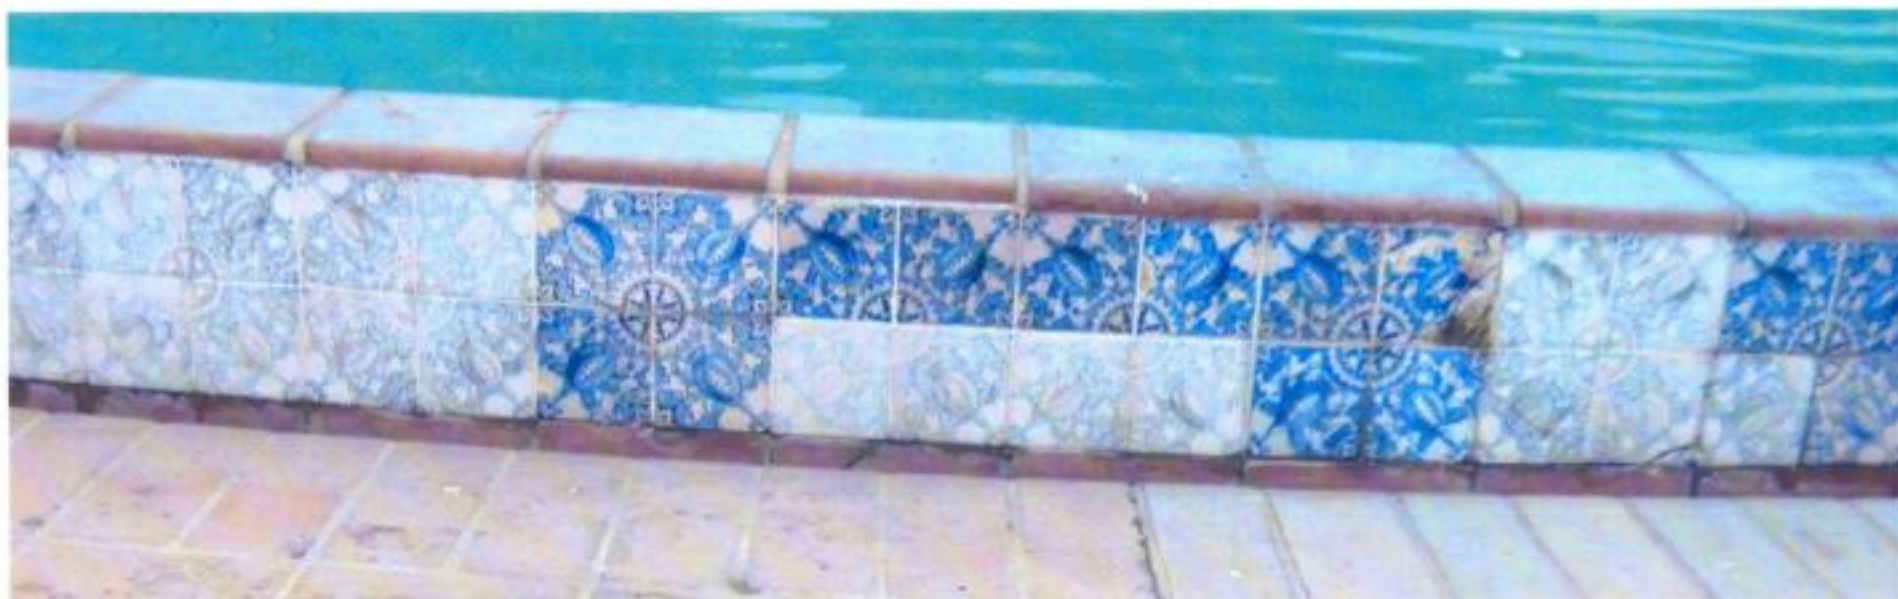
BLUE AND WHITE MAJOLICA TILES and TERRA COTTA COPING TILES

- Removal of **640 Original Tiles** to be Stored by the City of Beverly Hills
- Reproduce and Install New but Accurate Reproductions of Original Majolica Tiles
- Reproductions to Mimic the Originals as closely as Possible in Dimension, Pattern, Color and Sheen
- Use a Stable Finish for a Seamless Mortar and Grout Bed
- Additional Tiles to be Produced for Future Replacement Needs
- Reproduce **160 Terra Cotta Coping Tiles** that Mimic the Size, Thickness and Color of the Original Coping Tiles

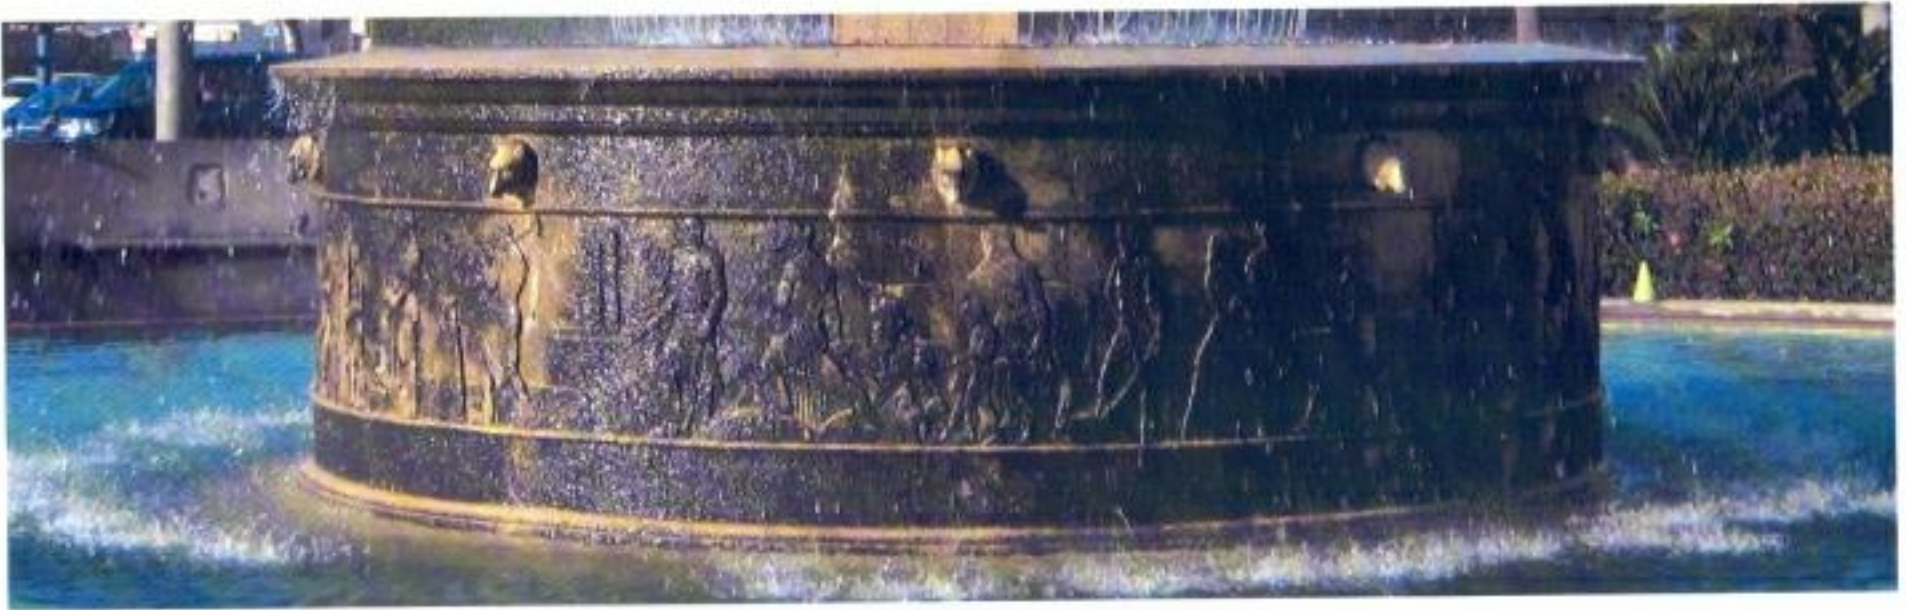
CENTRAL CAST STONE ELEMENT

- Cleaned with Conservation Grade Detergent
- Some Powerwashing may be Implemented
- Biological Growth to be Treated with Biocide
- Cracks in Stone to be Injected with Liquid Mortar
- Losses in Stone to be Filled with Inert Reversible Patching Materials Tinted to Mimic Surrounding Materials in Color and Texture

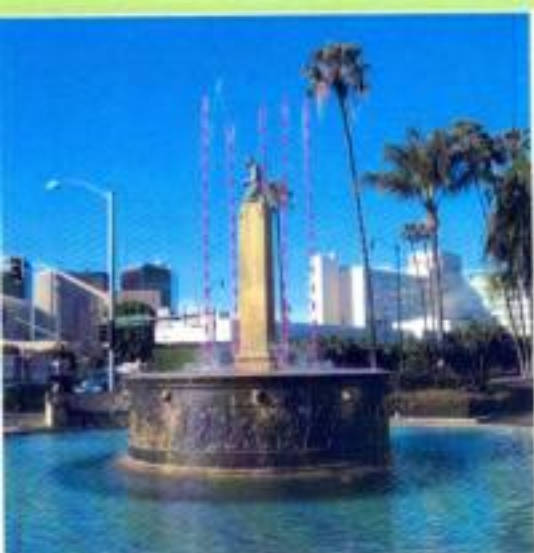
Inner Circle of Single Jets

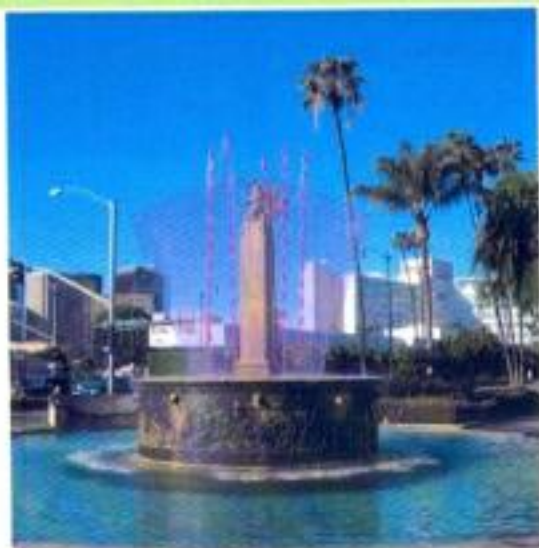
Outer Fountain Ring and
Inner Circle of Single Jets

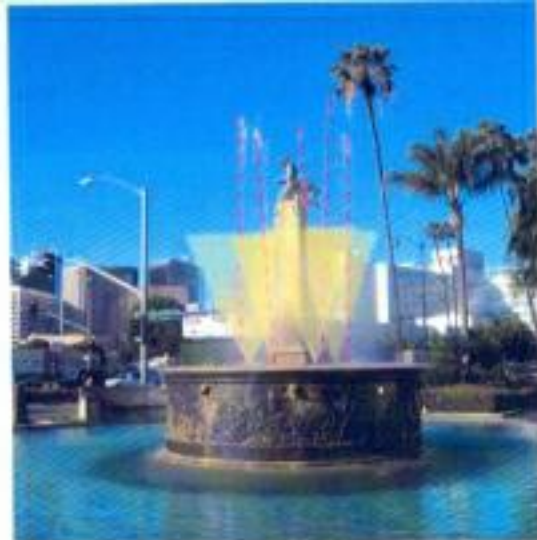
Middle Circle Spray and
Inner Circle of Single Jets

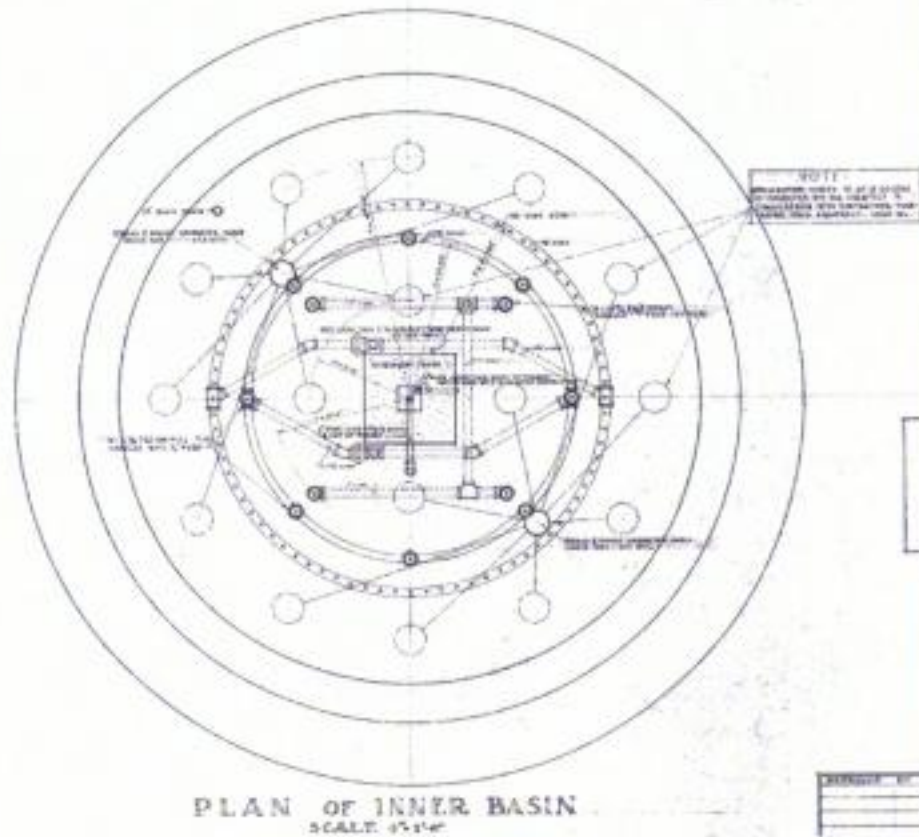
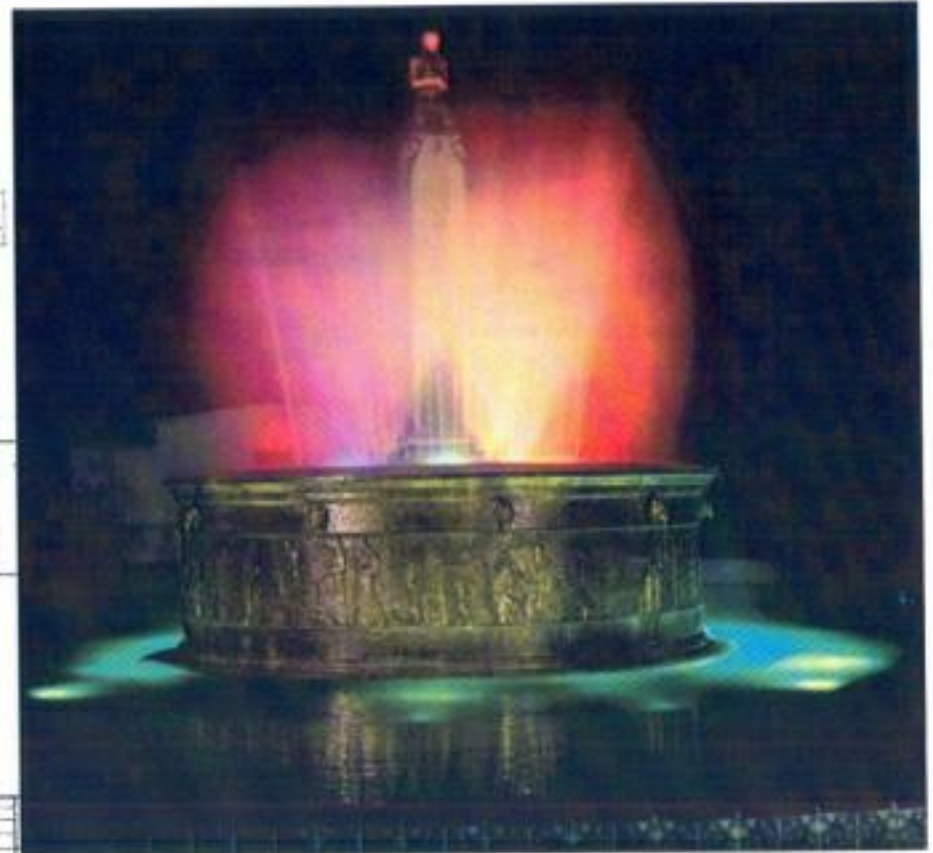
16 Lights at Upper Basin Shown in Original Drawings

- Replace Incandescent Light Fixtures with **LED Fixtures**
- LEDs Lights Last Longer Thus Lower Long Term Maintenance

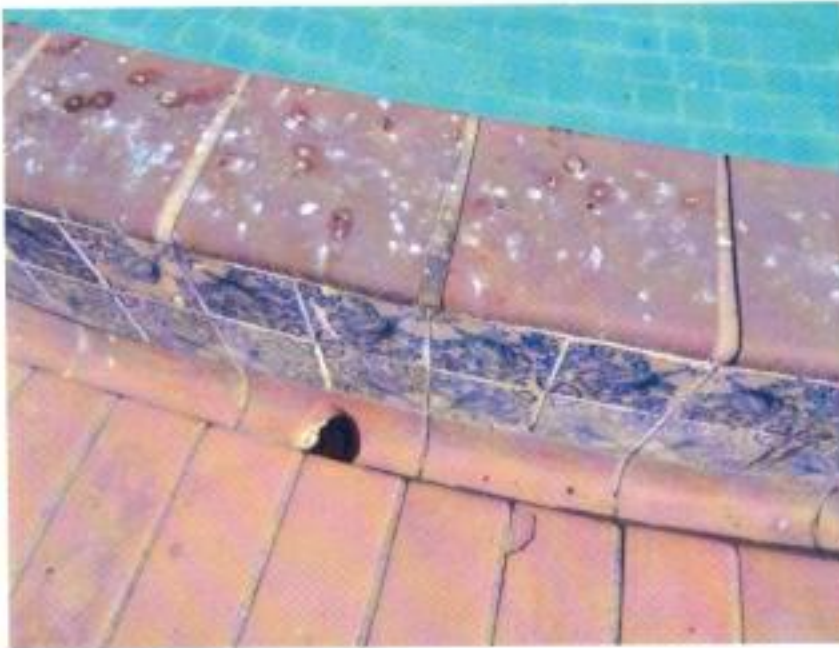
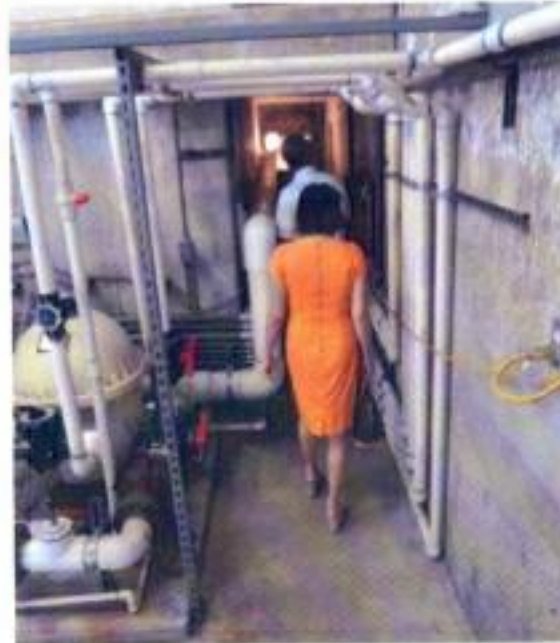
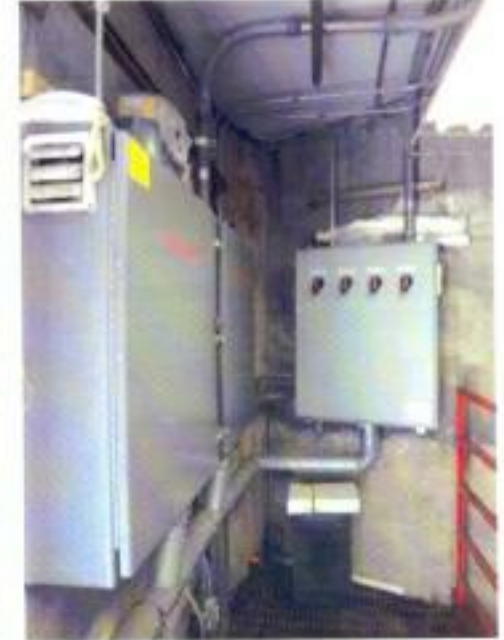
FOUNTAIN MECHANICAL SYSTEM

- Control Water Over Spray with Updated Wind Control System
- Clean Existing Trench Drain Surround at Lower Basin
- Replace Auto-Fill System
- Install New Circulation Suction and Discharge Points in Basin
- Remove Ad Hoc Skimmer/Discharge PVC System

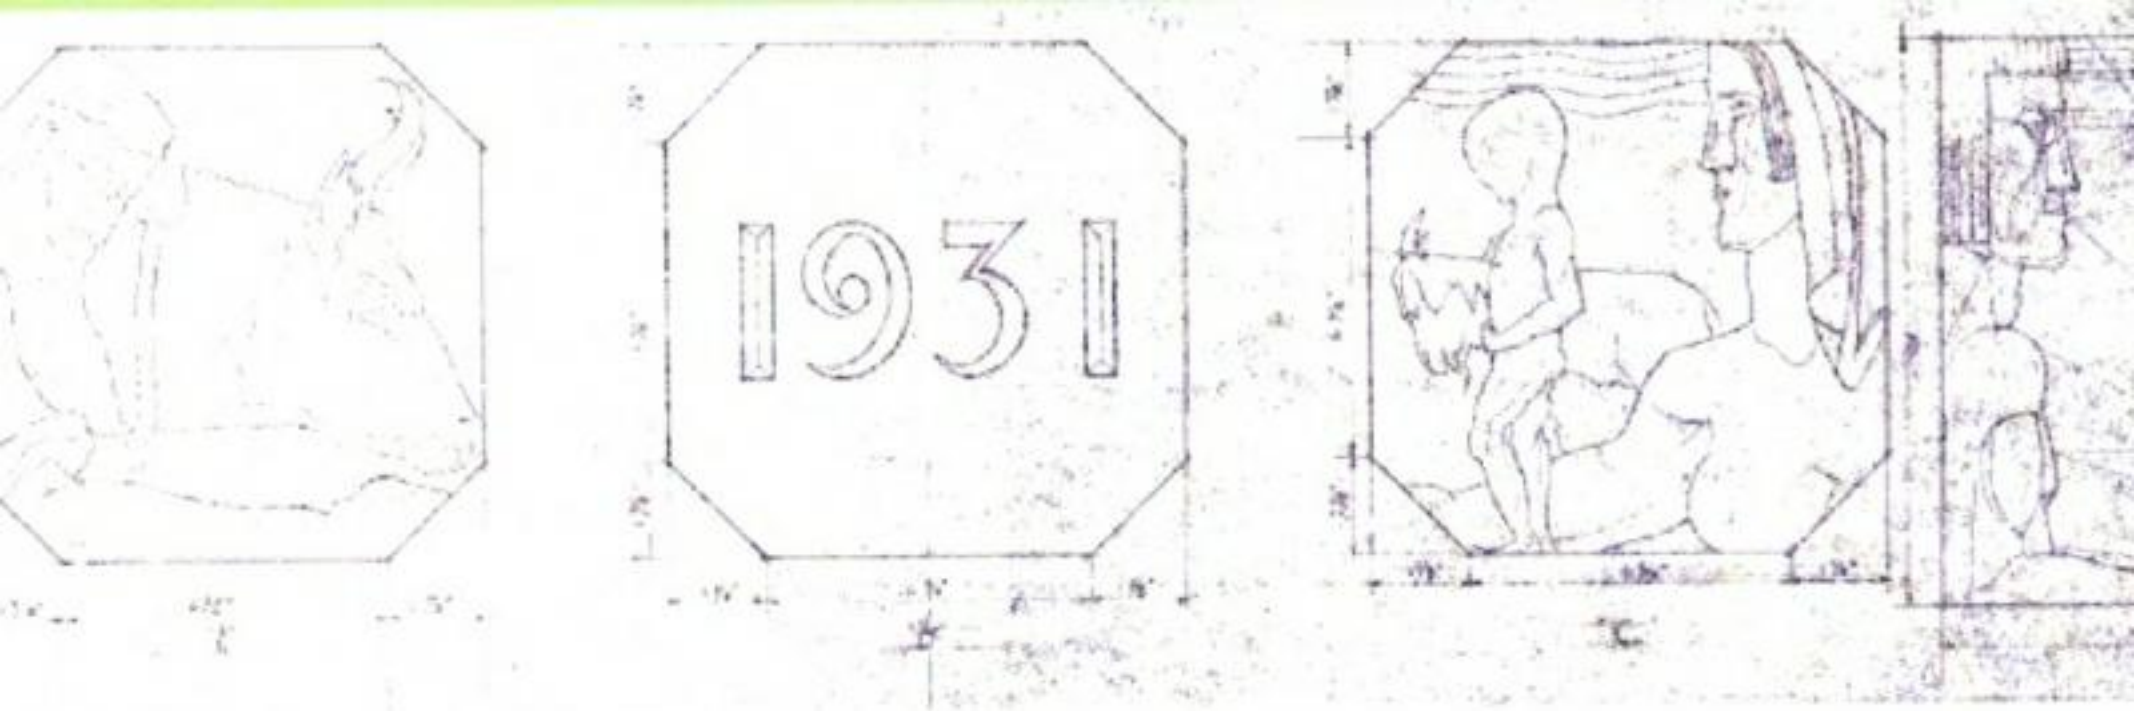
CAST CONCRETE BENCHES WITH BAS RELIEF INSERTS

- Clean Concrete with Conservation Grade Detergent
- Biological Growth to be Treated with Biocide
- Exposed Rebar to Filled and Coated
- Losses in Concrete to be Filled with Inert Reversible Patching Compound
- Toned to Mimic Surrounding Material in Color and Texture
